# Gallegos Canyon Unit

Tank treatment with 54GO 102 paraffin dispersant. 07/08/2015

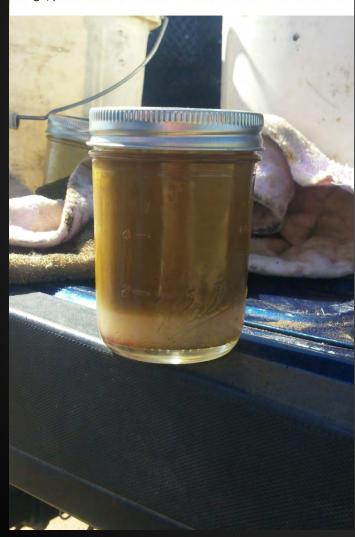
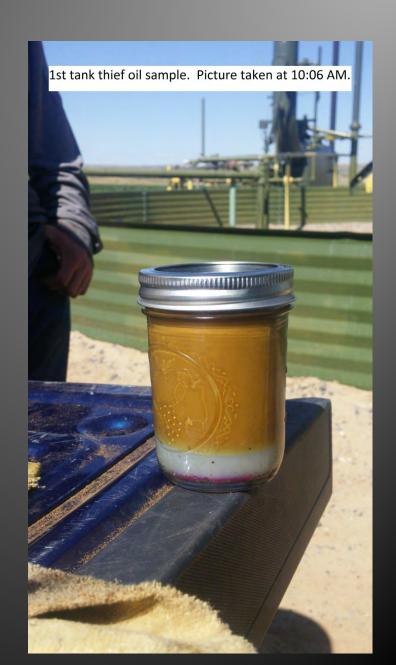
## 1st Tank Thief

1st tank thief sample pulled before chemical treatment at 9:40 AM. Added a very small amount of 54GO directly to sludge/paraffin at 9:45 AM. Picture was taken at 10:05 AM

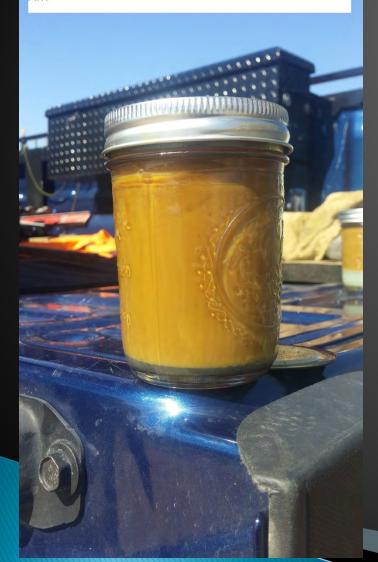
# 2<sup>nd</sup> Tank Thief

2nd tank thief pulled immediately after chemical injecting was completed. Picture was taken at 10:20 AM

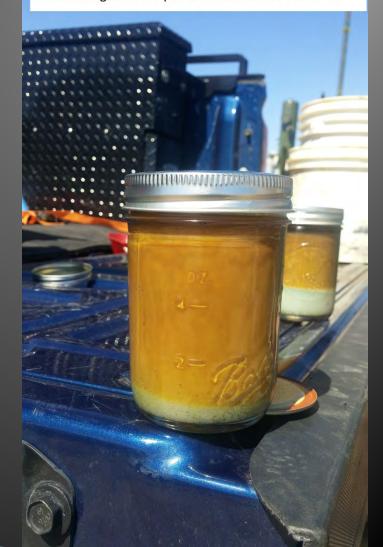
2nd tank thief oil sample. Jar had just been knocked over on its side right before picture was taken at 10:31 AM

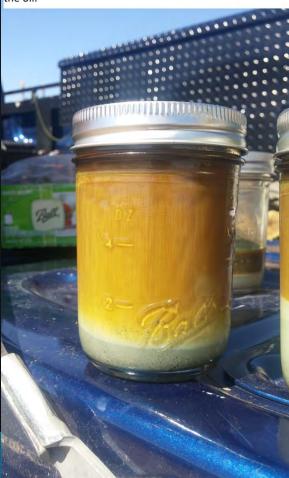
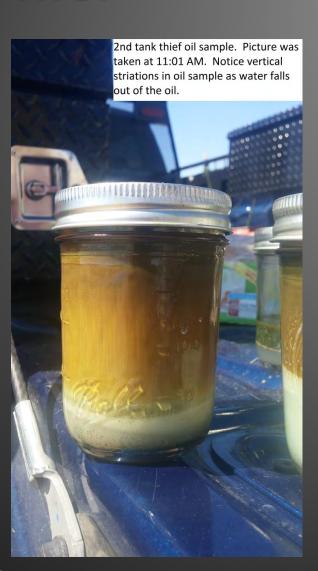
# 2<sup>nd</sup> Tank Thief

2nd tank thief oil sample. Picture was taken at 10:46 AM. Notice vertical striation in oil sample as water falls out of the oil.

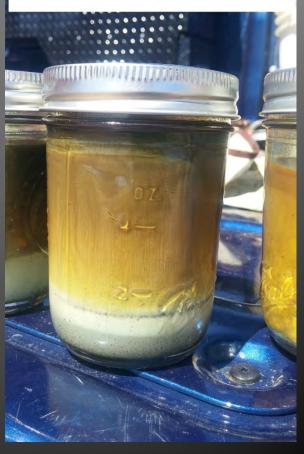
2nd tank thief oil sample. Picture was taken at 11:16 AM. Notice vertical striations in oil sample as water falls out of the oil. Also notice the change in oil as the water continues to fall out as well as the BS&W falling to the bottom.

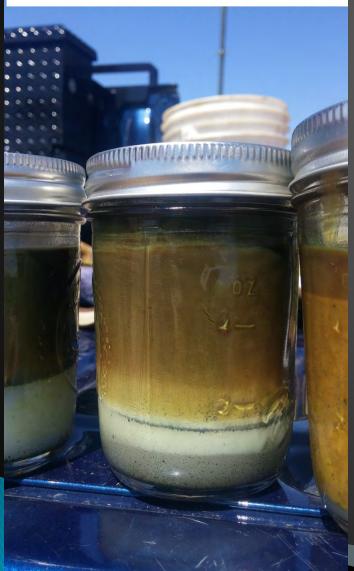
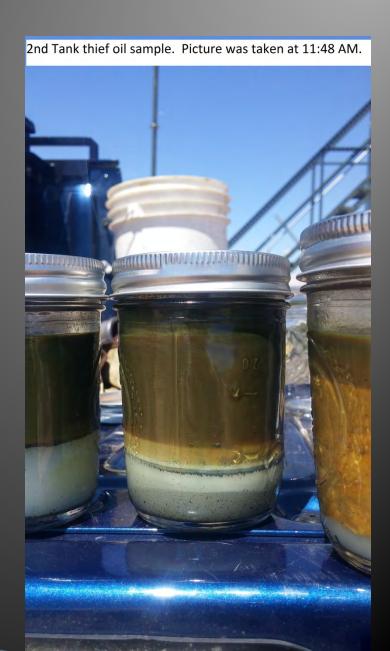
# 2<sup>nd</sup> Tank Thief

2nd Tank thief oil sample. Picture was taken at 11:30 AM.

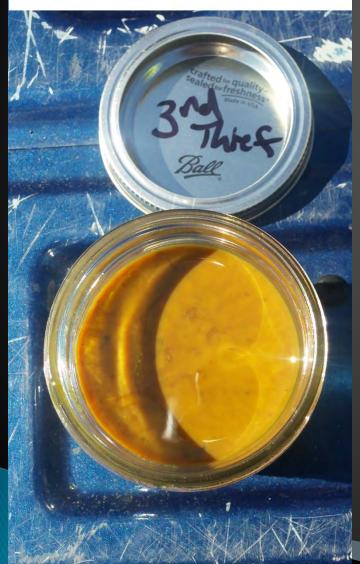
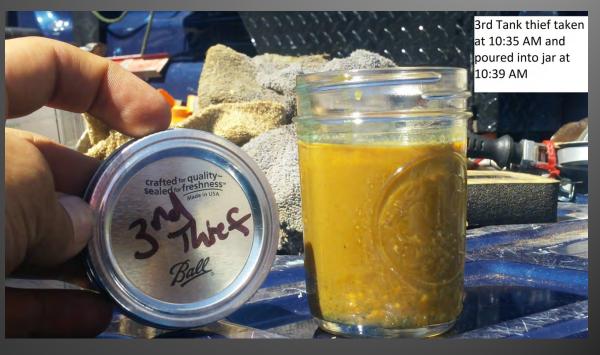
# 3rd Tank Thief

3rd Tank thief taken at 10:35 AM and poured into jar at 10:39 AM
